EP JN:	17104-22-01
Re:	<b>Structural Assessment Report HPPOA Activity Center</b>  15-1570 Maku'u Drive Kea`au, HI 96749
TMK:	(3) 1-5-023: 040

On December 14, 2022, Engineering Partners (EPI) performed a site investigation at the HPPOA Activity Center located in Hawaiian Paradise Park, Hawaii. The purpose of the investigations is to evaluate the structural condition of the building which was originally constructed in 1980. The following is a summary of the results of the assessment.

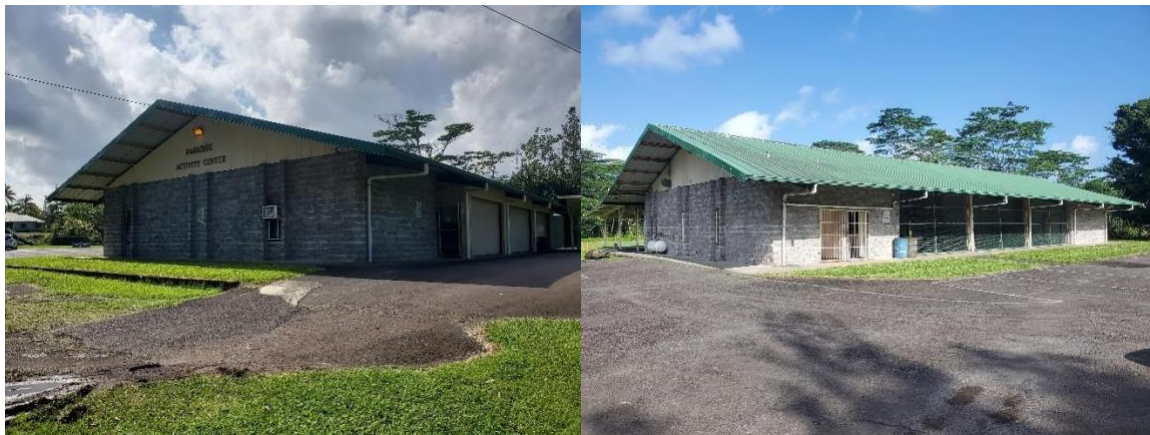
The building measures approximately fifty feet wide by one hundred feet long and is constructed with preengineered structural steel framing and a concrete slab-on-grade foundation. Six clear-span steel moment frames provide gravity support for the roof framing and lateral support in the north-south direction. These frames are spaced twenty feet apart. Concrete masonry shear walls are located at each end of the building which provide lateral support in the east-west direction. These walls enclose a kitchen/bath at one end and library/storage rooms at the other. Most of the structural framing is exposed and visible with exception of the buried footings and framing above kitchen/bath and library/storage ceilings. Record drawings of the original construction were not made available for our review.

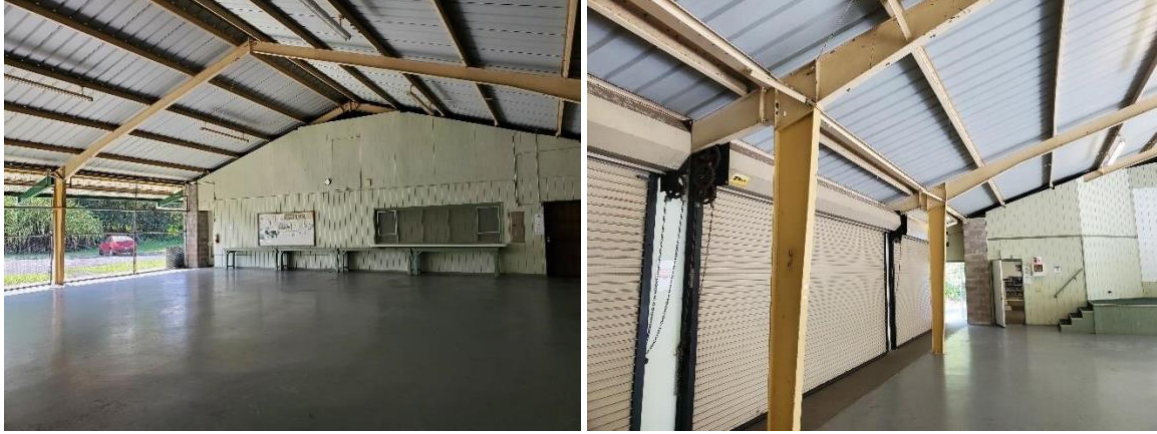
Overall, the structural steel and concrete masonry framing is in fair condition. The structural steel framing is painted, but some of the paint appears to be failing. There is surface corrosion that is visible where the paint has failed, but this corrosion has not caused significant material loss. The corrosion is most severe at the anchor bolts and base plates on the South side of the structure, which are more exposed to exterior elements. There are also some sections at the exposed ends of the purlins that exhibit material loss due to corrosion.

- 1) Paint the structural steel including the top of the roof purlins. First remove any loose paint or corrosion, then clean and dry the surface to be painted. “Loose” implies any material that can be removed with a knife. Prepare the surface to be coated as directed by the paint manufacturer. Ensure the ambient condition is as dry as possible to ensure paint doesn’t peel or blister. This work should be performed within 5 years to minimize further corrosion and mitigate potential material loss of structural members.

- 2) Replace the metal roofing when the steel is painted. This will facilitate painting of the purlins.
- 3) Sister on a new section of purlin at eaves and other locations where corrosion has resulted in material loss. The new purlin should be the same depth, width, and thickness of the existing purlin. At cantilever ends the length of new purlin should be three times the length of the damages section.

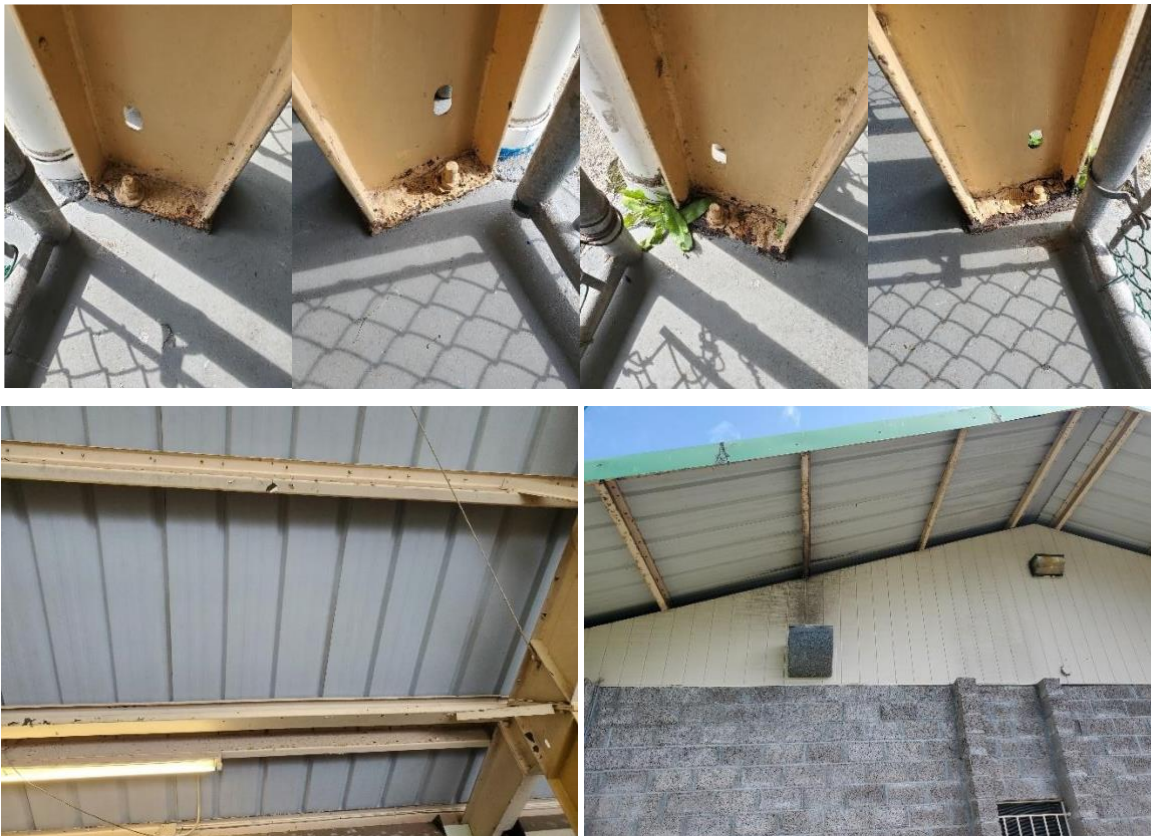
The concrete masonry walls have hairline cracks at the corners where the rafters penetrate the wall. The lateral loads are transferred from the roof framing to the masonry walls at these locations. Given the cracks are generally less than ¼-inch wide these can be filled with epoxy repair material. Other than the visible corrosion and hairline cracks the structural steel and concrete masonry framing are in good condition.

- 4) Repair the spall in the concrete masonry by using an epoxy injection resin such as Hilti CI 060 EP Crack Injection System or Sikadur Crack Repair Kit. If required, repair spalled masonry with a onecomponent, shrinkage compensated, fiber reinforced repair mortar with integral corrosion inhibitor, such as Planitop X as manufactured by Mapei. Before installing the repair materials, the existing deteriorated or damaged concrete masonry shall be sawcut and removed. Any exposed
