Hawaiian Paradise Park OA *Keaau, HI*

Report #: 33286-0
Beginning: July 1, 2025
Expires: June 30, 2026

RESERVE STUDY

November 4, 2025

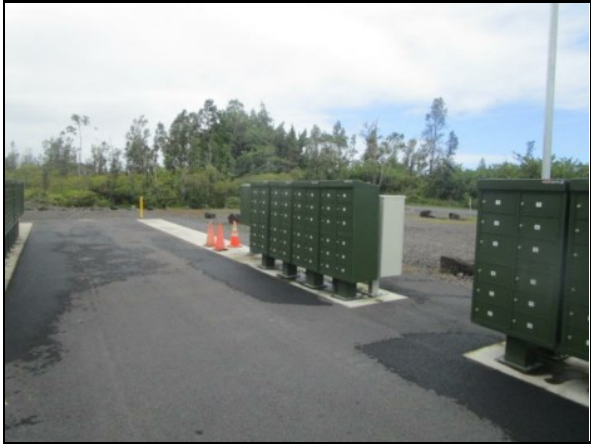
Comments: The mail parks were very recently paved and sealed. Asphalt surfaces require periodic reconstruction to restore the integrity of the base to accommodate the asphalt surfaces properly. A longer useful life is given as this section of asphalt will not receive traffic from vehicles. The useful life shown is based on the assumption that the association will conduct regularly scheduled repairs and resealing (refer to #202). It is possible to extend the useful life of the asphalt by conducting an overlay project, but this option should be carefully vetted by the Board to ensure that the overlay project will be successful under the current asphalt conditions.

Useful Life:
40 years

Remaining Life:
38 years
