**Hawaiian Paradise Park OA
Roads
*Keaau, HI***

Report #: 33286-0
Beginning: July 1, 2025
Expires: June 30, 2026

RESERVE STUDY
"Full"

November 4, 2025

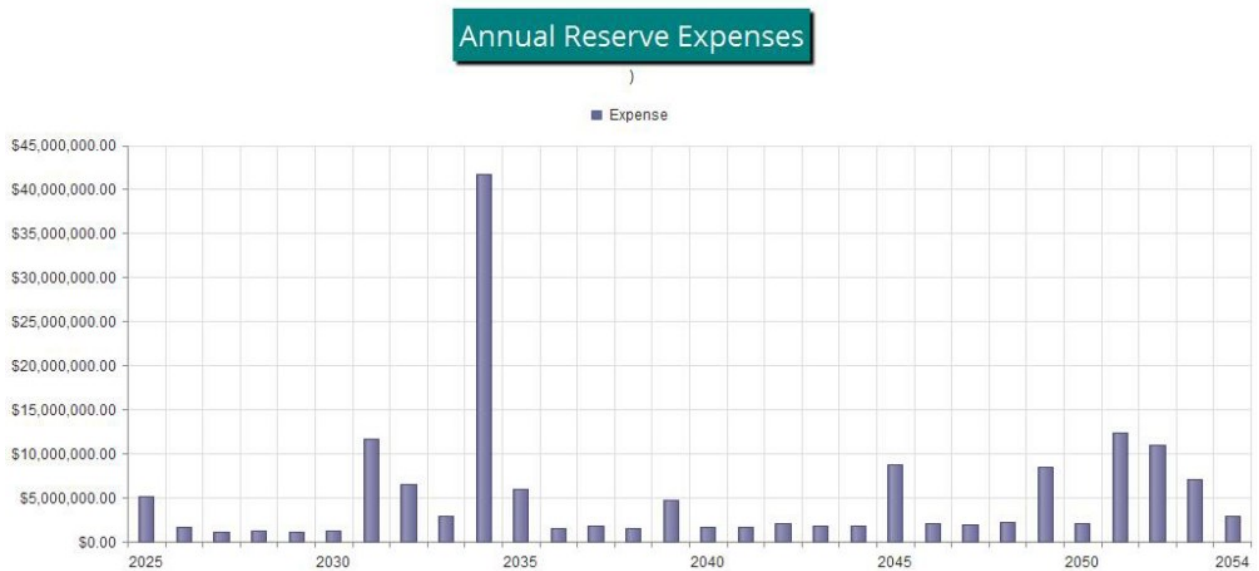
Figure 1

While this Reserve Study looks forward 30 years, we have no expectation that all these expenses will all take place as anticipated. This Reserve Study needs to be updated annually because we expect the timing of these expenses to shift and the size of these expenses to change. We do feel more certain of the timing and cost of near-term expenses than expenses many years away. Please be aware of your near-term expenses, which we are able to project more accurately than the more distant projections. The figure below summarizes the projected future expenses at your association as defined by your Reserve Component List. A summary of these components are shown in the Component Details table, while a summary of the expenses themselves are shown in the 30-yr Expense Summary table.

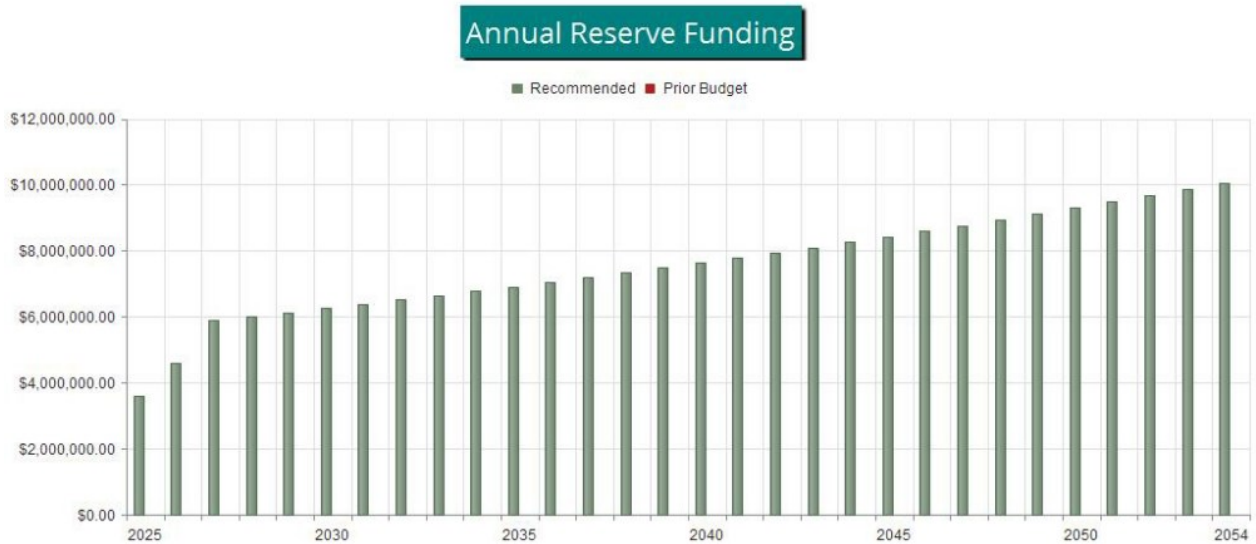
Figure 2

Based on your current Percent Funded and your near-term and long-term Reserve needs, we are recommending budgeted transfers of **\$300,000** per month this Fiscal Year as well as a 2025 special assessment of **\$16,100,000** and a 2029 special assessment of **\$30,000,000**. The overall 30-yr plan, in perspective, is shown below. This same information is shown numerically in both the 30-yr Summary and the Cash Flow Detail tables.

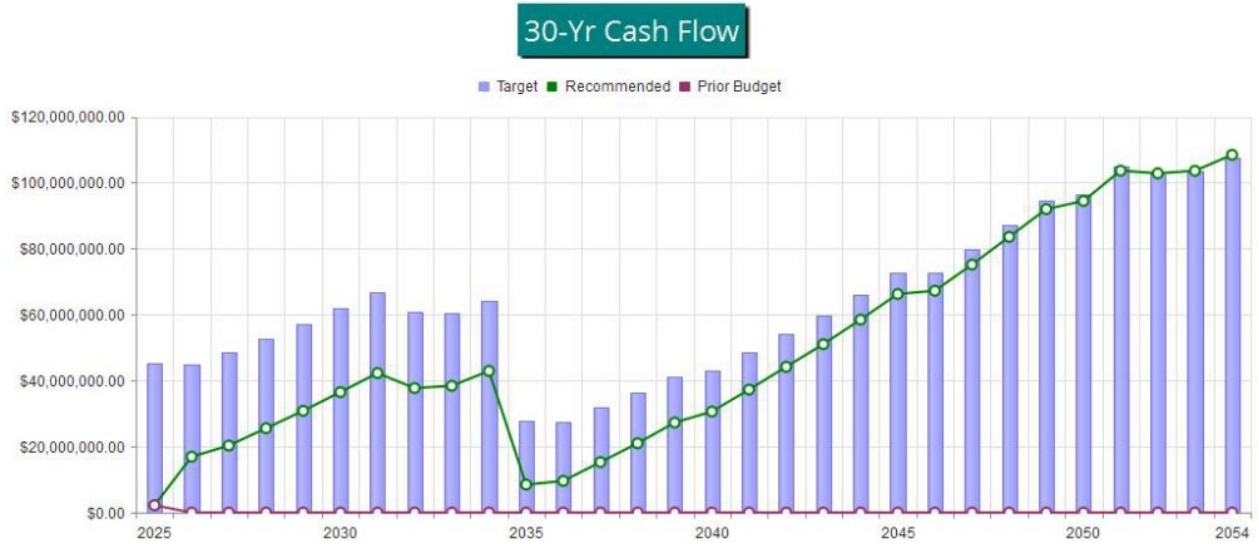
Figure 3

The following chart shows your Reserve balance under our recommended Full Funding Plan and at your current budgeted transfer rate, compared to your always-changing Fully Funded Balance target.

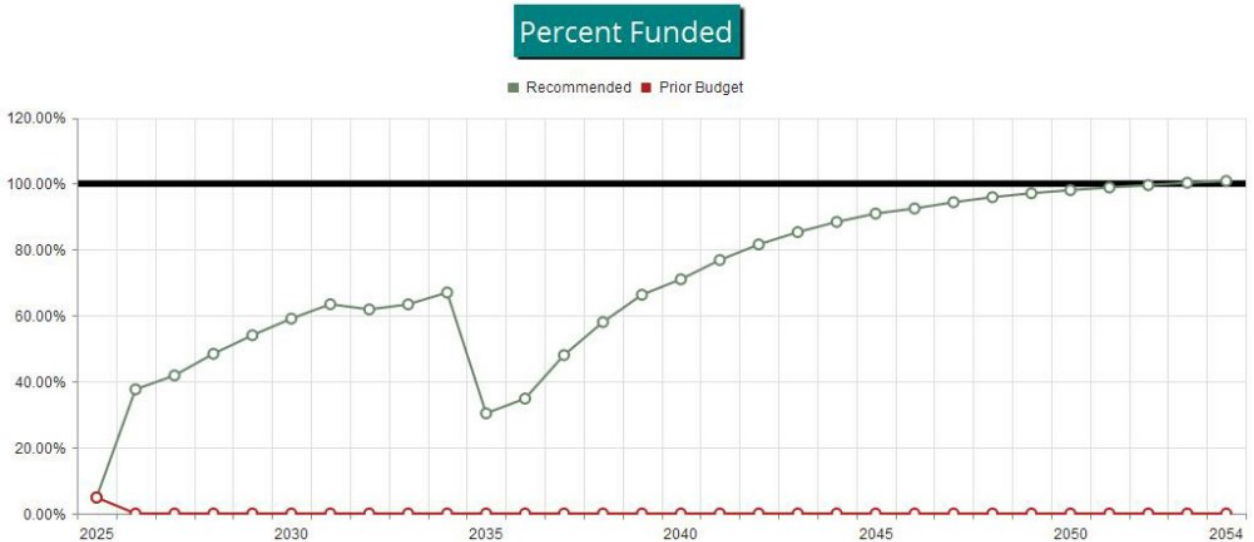
Figure 4

This figure shows the same information plotted on a Percent Funded scale. It is clear here to see how your Reserve Fund strength approaches the 100% Funded level under our recommended multi-yr Funding Plan.

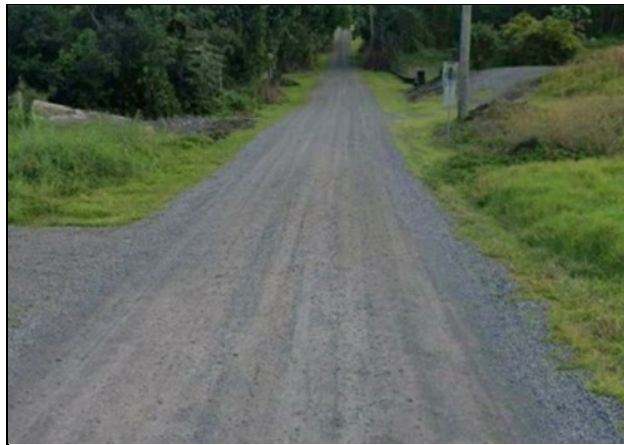
Comp #: 202 Asphalt - Repair/Reseal

Useful Life:
1 years

Remaining Life:
0 years
